## Setting Sail on the *Pacific Spirit*

A Case Study by Parker LORD Staff Engineer John Bergstrom

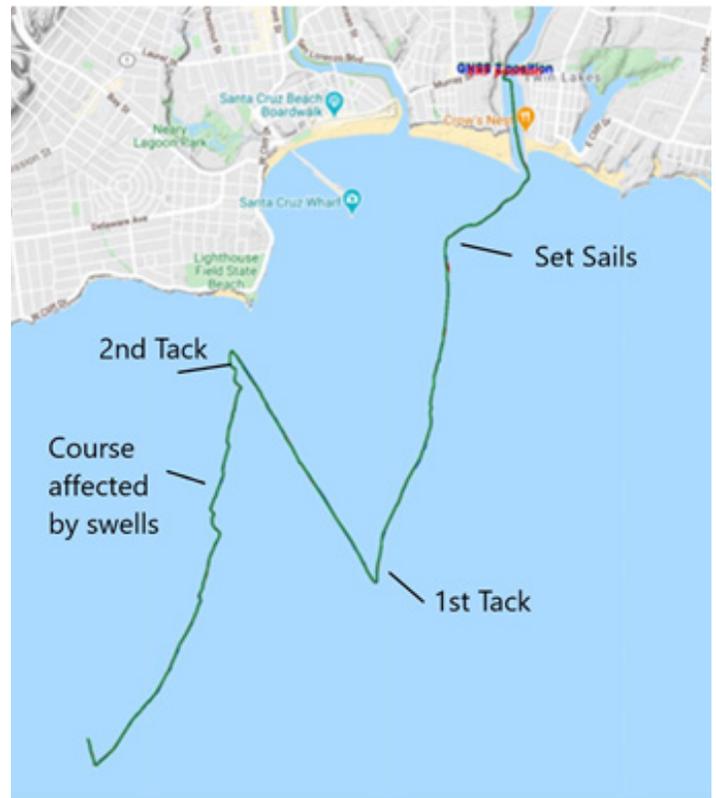
Figure 2. Google Earth: Dual Antenna GPS and EKF solution plots

Later that evening, I used a Python script with MicroStrain's Inertial Protocol (MIP) to plot the GPS data and the Extended Kalman Filter (EKF) data on Google Earth (Figure 2). The Google Earth map shows the boat's route during the sail in great detail.

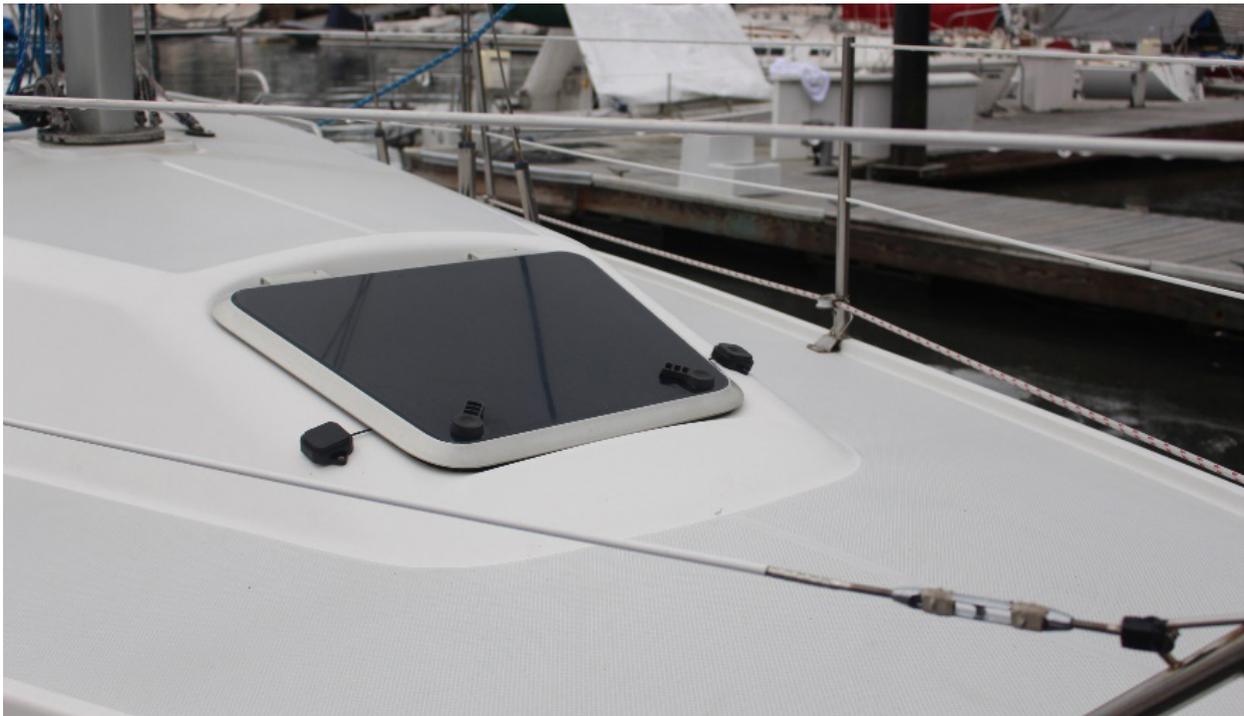
Figure 3. Dual antennas on the foredeck of the Pacific Spirit

The GQ7 was positioned in the forward cabin with a dual antenna on the foredeck with approximately 0.7 m separation equally spaced from the GQ7 (Figure 3).

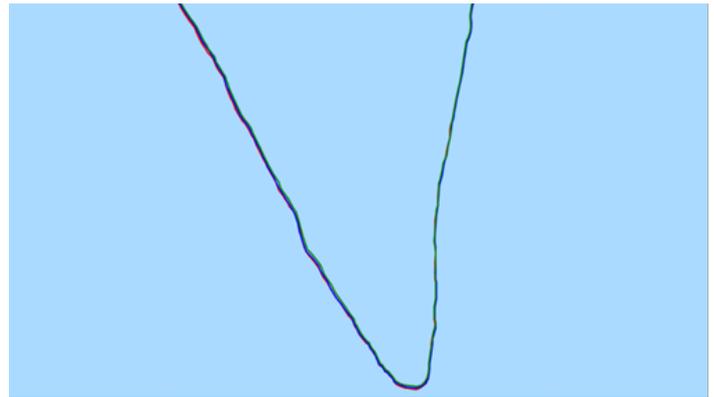
Figure 4. Port tack to starboard tack, no issues

The route of the boat makes a smooth turn into and through the wind and continues without losing forward progress (Figure 4). This indicates the helm and the crew worked together to turn the boat and in parallel and move the jib from the port side to the starboard side of the *Pacific Spirit*.

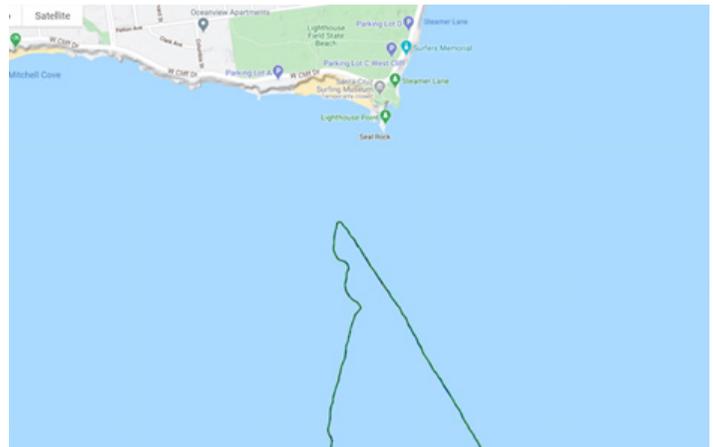
Figure 5. Starboard tack to port tack with heavy swells and inexperienced helm

In contrast, Figure 5 shows the route for a poor tack. The boat immediately loses ground and the path of the boat is not steady. Specific reasons for a poor tack are usually the helm over steers the turn or the crew does not trim the jib sheet smoothly.

The combination of the helm not holding a steady course, the increase in wind, and swells affected the forward progress of the boat, resulting in a wavy heading.

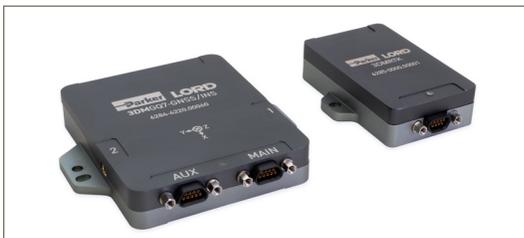
Honorary Pacific Spirit crew members: 3DMGQ7 and RTK

We set sail on the Pacific Spirit and brought along a MicroStrain **3DMGQ7** with dual antenna and RTK modem to collect navigation and position data using SensorConnect software.

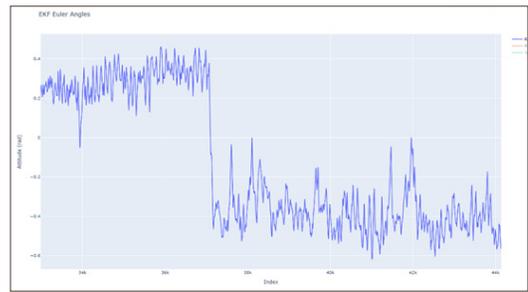
Figure 6. Heel (roll) from port tack to starboard tack

Another interesting observation is the EKF solution for the Euler angles (pitch, roll, yaw) shows the heel (roll) of the boat as it is sailing. Figure 6 displays the change in the heel when the boat goes from a starboard tack to a port tack and it reinforces the idea that a sail boat is not a pontoon boat.

The Catalina 32 was heeling from 25° to 35° - the rail of the boat was in the water (not for the faint of heart!). The heave, which is the vertical motion of the boat, was 1-2 meters in the heavier swells.

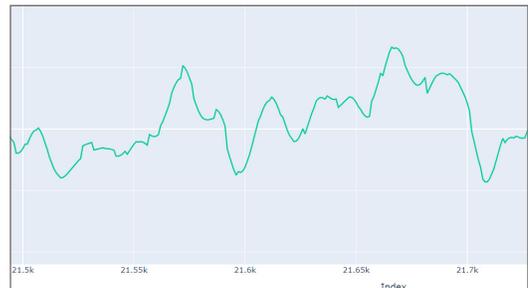
Figure 7. Heave in 5-7 ft swell

The GQ7 data was detailed, quantified information about the performance of the crew and the boat in different weather and sea conditions that would otherwise be lost. Figures 7 and 8 show the heave and heave velocity of the boat while sailing through swells of 5 ft to 10 ft.

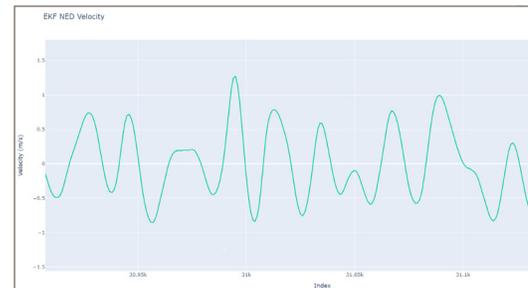
Figure 8. Heave velocity
